# Manhole Inspection Summary

Manhole # S53C2\_001MH

Insp Date: **6/8/09 12:13 PM**

**Location** Address: **2155 Northbridge Ave.**

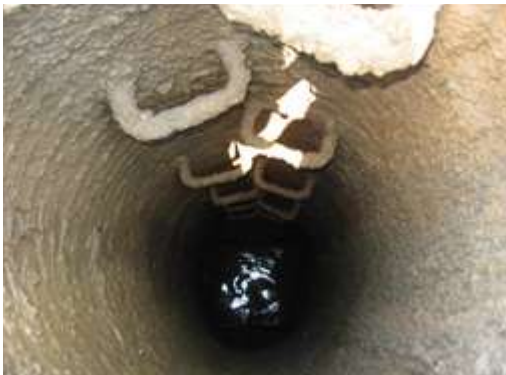
Steps

**Steps** Count: **10** Missing: **0** ☒ **Corroded**

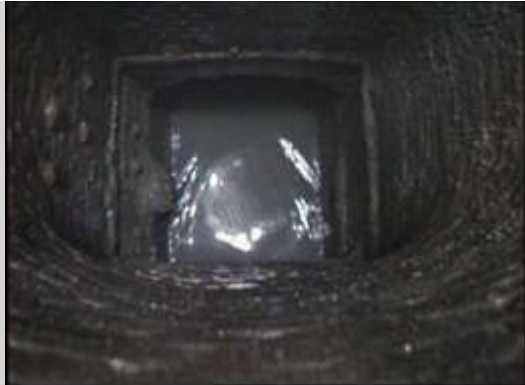
### Pipe Out @ 12 O'Clock

Pipe Height: (in.) Rod and Bar  
Pipe Material: **Clay** ☐ Pipe Lined  
Invert Depth: (ft.) Flow Characteristics: **Fast**  
Deposits: ☒ None ☐ Mud ☐ Sludge ☐ Debris ☐ Grease  
Silt Depth: (in.) Deposits Extent:  
Infiltration: **None** Pipe Seal Cond: **Sound**

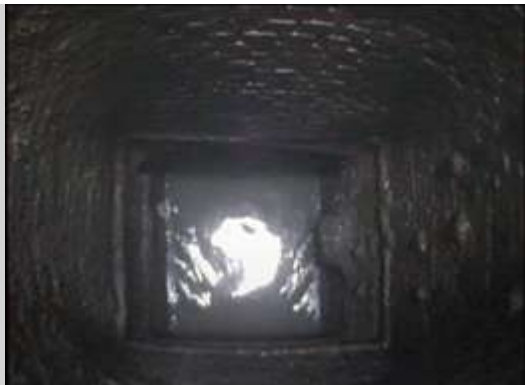
### Pipe In @ 6 O'Clock

Pipe Height: (in.) Rod and Bar (Angled)  
Pipe Material: ☐ Pipe Lined  
Invert Depth: (ft.) Flow Characteristics: **Fast**  
Deposits: ☒ None ☐ Mud ☐ Sludge ☐ Debris ☐ Grease  
Silt Depth: (in.) Deposits Extent:  
Infiltration: **None** Pipe Seal Cond: **Sound**
